Efectis Nederland report

2008-Efectis-R0733[Rev.1]

Determination of the fire resistance according to
EN 1366-3: 2004 of the standard configuration for
testing sealing materials for use with metal pipes

Date November 2008

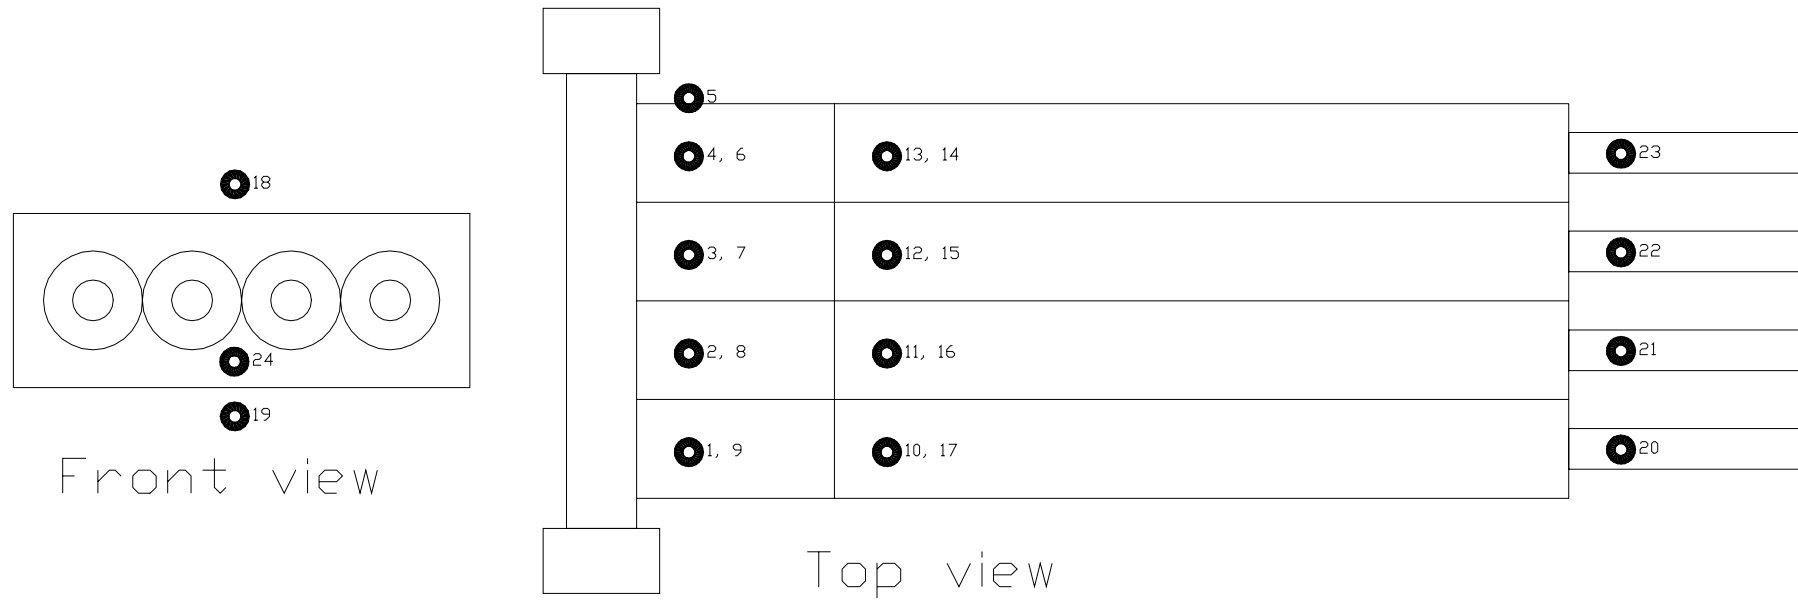
| Time [min] | Observation |
|---|---|
| | After the test it was observed that the cap of one of the steel pipes had fallen of. That is probably the reason that TK5 23 had a rapid temperature rise, because the thermocouples TK5 20, TK5 21 and TK5 22 fixed on comparable positions on another steel pipe and on copper pipes as well with nearly the same dimensions showed relatively lower temperature rises during the test. |

Figure A22 Location of the thermocouples on penetration 5

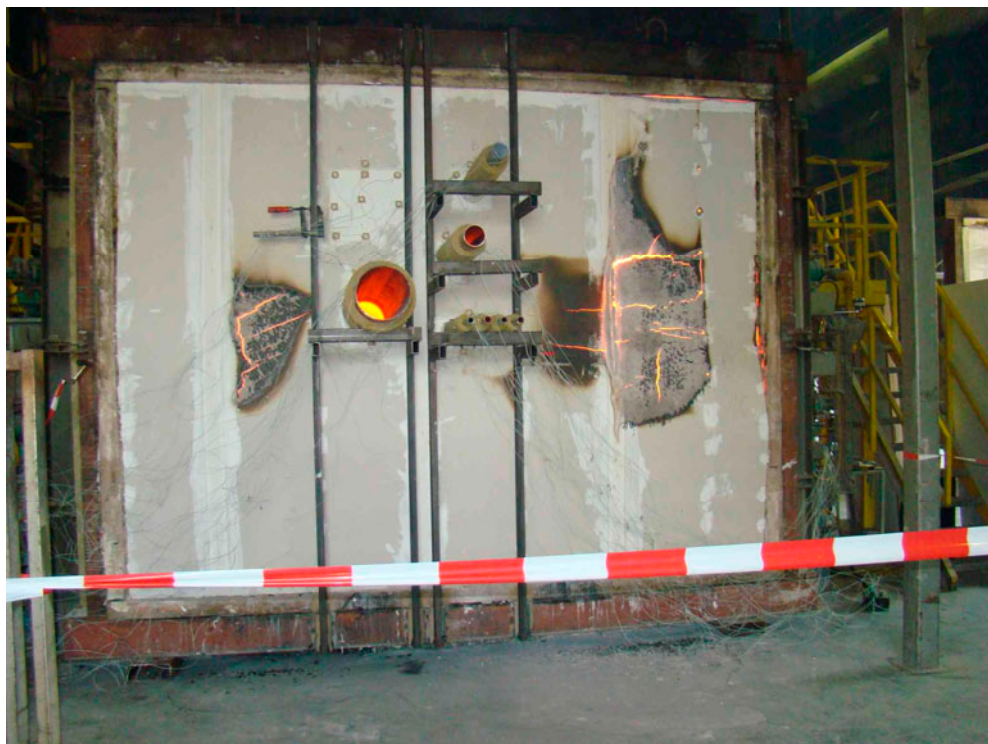
| Time [min] | Observation |
|---|---|
| 50 | The supporting construction has been deformed substantially and bending away from the furnace. Due to the bending the wall is resting against the steel supporting construction of the pipes |
| 61 | On the right side a large crack is forming in the supporting construction. The surface is turning black |

Photograph B2 Specimen seen from the non exposed after 76 minutes of heating

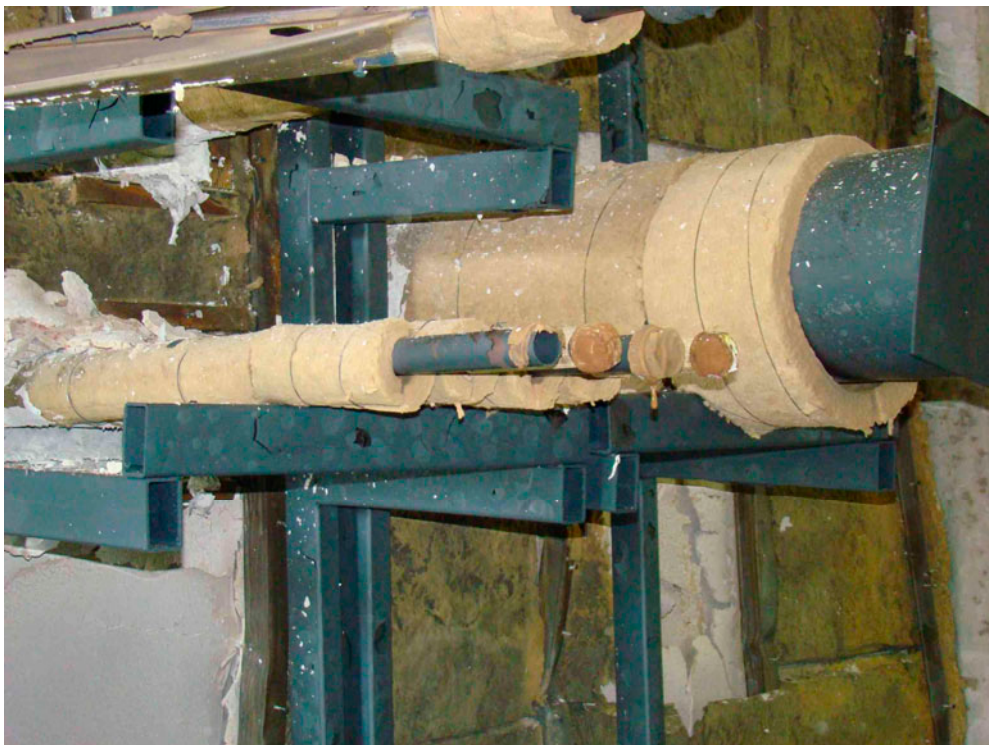
Photograph B4 Specimen 5 close up, cap of a steel pipe has fallen off
