Determination of the fire resistance according to EN 1366-3:2009 of Flamro pipe closure devices directly mounted in a standard aerated concrete floor

Report no.	2018-Efectis-R000996
Sponsor	Flamepro BV P.O. Box 146 3100 AC SCHIEDAM The Netherlands
Prepared by	Efectis Nederland BV
Notified body no.	1234
Author(s)	P.G.R. Scholten B.Sc. L. Schimmer - Herder BBE
Project number	ENL-17-001207
Date of issue	July 2018
Number of pages	46

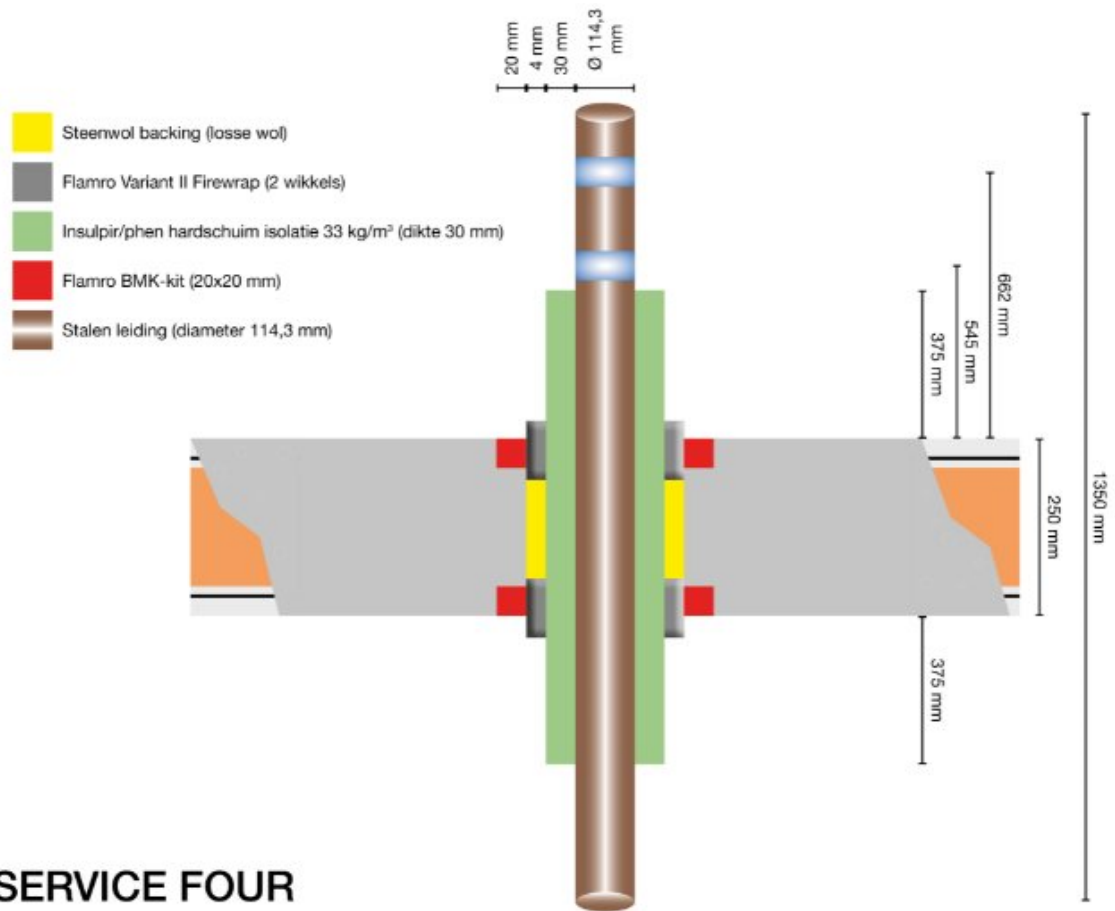
Figure 5 Service no. 4

Time [min]	Service	Observations
0		Commencement of the test.
9	5	End of criterion integrity, flames > 10 sec.
57	4	An opening appeared in the insulation material
70	10	Thermocouple 10Ax is disconnected
101	8	End of criterion integrity, flames > 10 sec.
112		End of heating after consulting the client

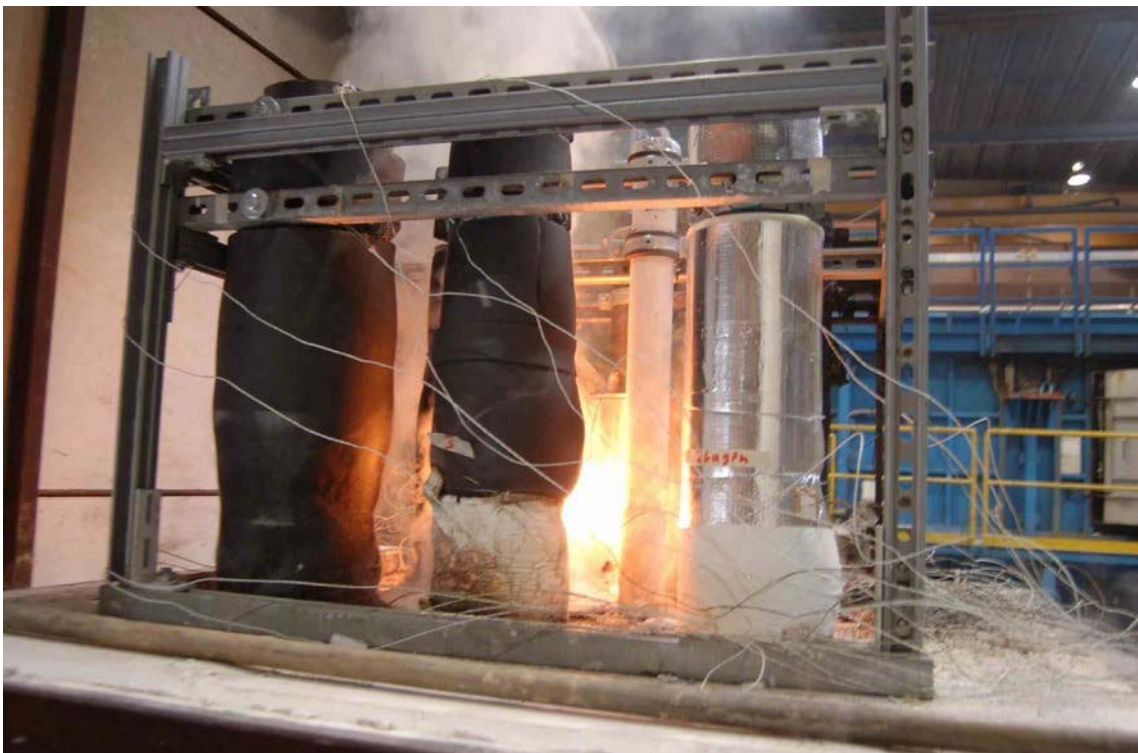
Photograph 10 Specimens after 101 min of heating, flaming on service no. 8
